Subject: Transportation Peer Review Services  
Beaver Brook Mill Redevelopment  
88, 91, 101 Mill Street, Dracut, MA

MDM Transportation Consultants, Inc. (MDM) is pleased to provide you with the following initial transportation review comments for the above-referenced project. These comments have been prepared based on a site visit in July 2025 and review of the documents identified below. To facilitate response by Applicant, review items requiring response are noted in ***Bold Italic***.

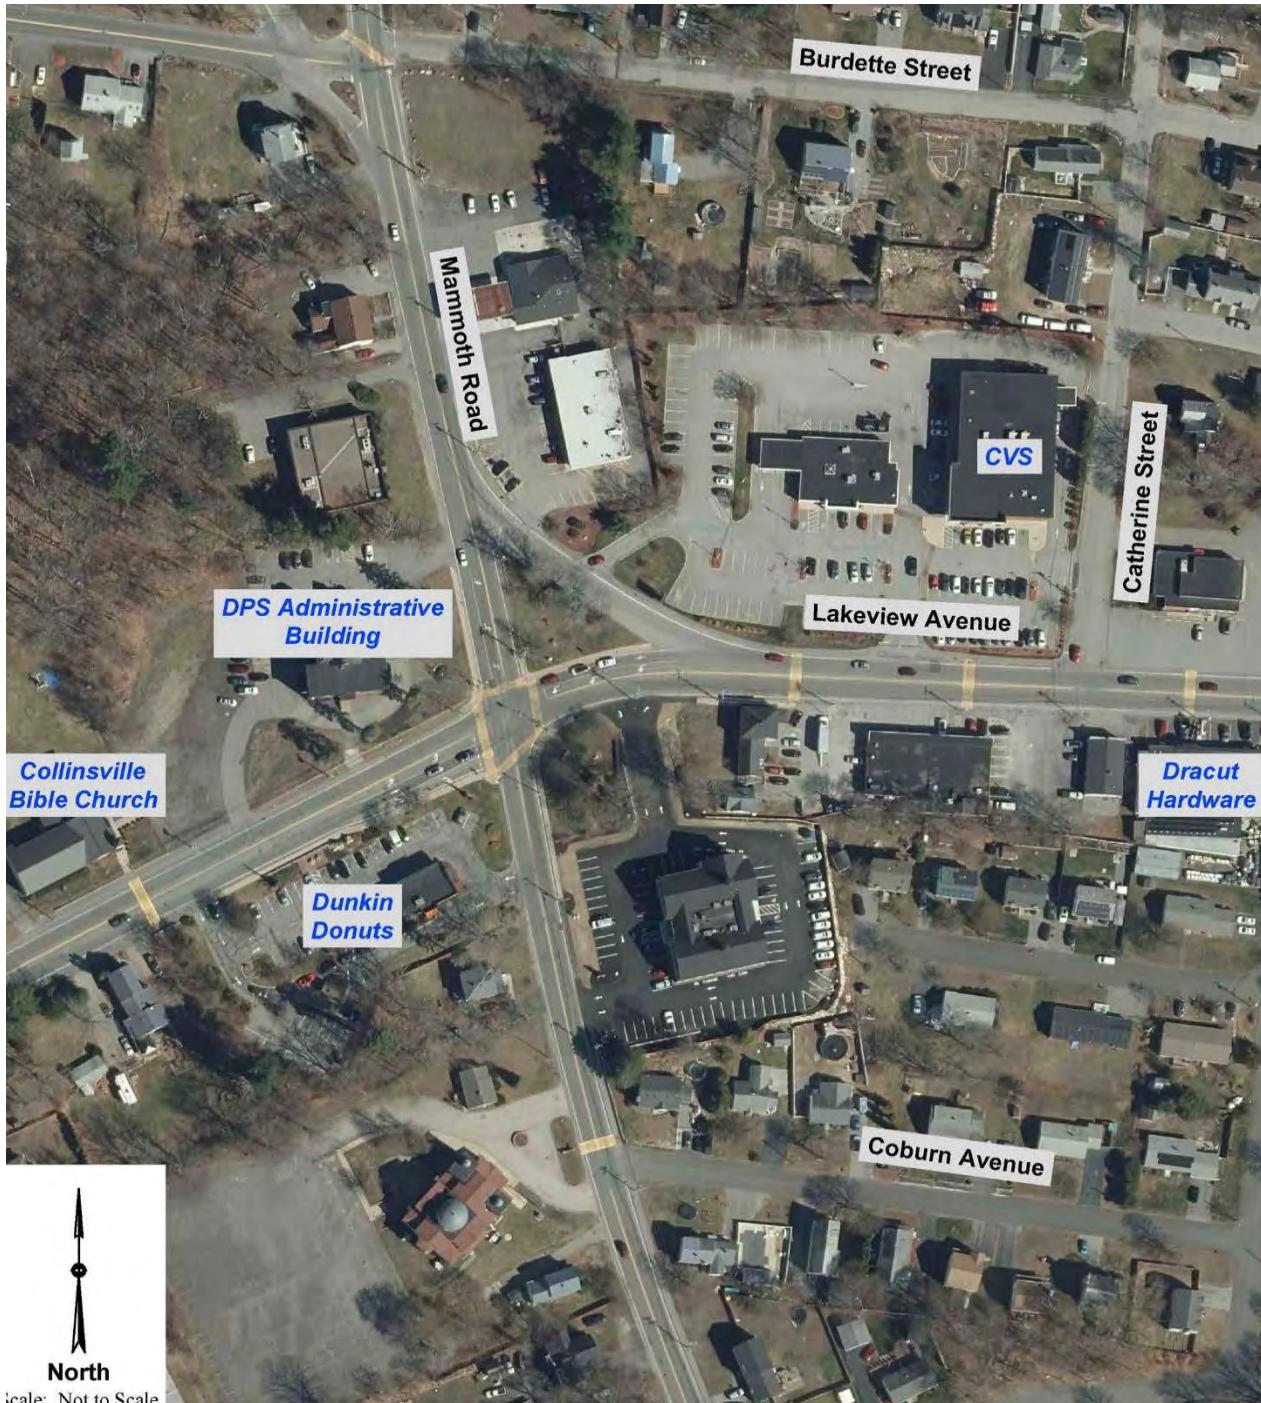
Figure 2: Aerial – Lakeview Avenue at Mammoth Road

Lakeview Avenue meets Mammoth Road to form a slightly skewed four-legged, signalized intersection under local jurisdiction. The eastbound Lakeview Avenue approach widens from a single travel lane with a short taper to provide an exclusive left turn lane, an exclusive through lane, and an exclusive right turn lane. The Lakeview Avenue westbound approach provides an exclusive left-turn lane, an exclusive through travel lane, and right turning vehicles are able to bypass the signal control by way of a single lane channelized by a large triangular shaped island. Traffic in this lane is under STOP sign control on its approach to Mammoth Road. The Mammoth Road southbound approach provides an exclusive left-turn lane and a shared through/right turn lane. The Mammoth Road northbound approach provides a single shared left/through/right travel lane. There are sidewalks provided at the intersection with signalized crosswalks across all four approaches. Land uses at the intersection include a Dracut Public School administration building, a small public park, a Dunkin' restaurant, and commercial/retail properties. While a full access/egress driveway for the Dunkin Donuts on the southwest corner is offset some 300 feet along Lakeview Avenue from the signalized intersection, another driveway, which primarily serves vehicles

exiting the drive-through, is offset only 140 feet from the intersection along Mammoth Road. Additionally, a recently constructed medical office building on the southeast corner has a driveway with an offset some 275 feet along Mammoth Road from the signalized intersection, however another enter/exit driveway is offset only 100 feet from the intersection along Lakeview Avenue.

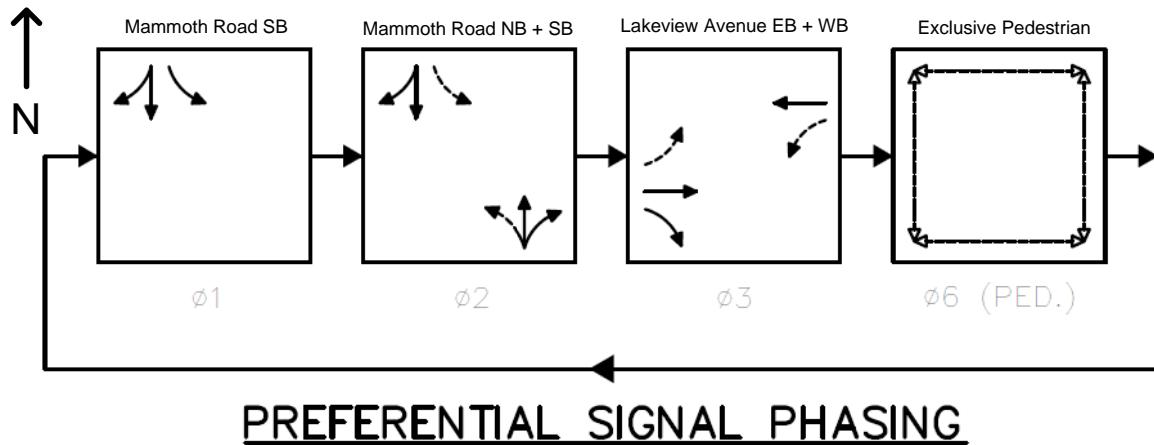
Figure 3: Phasing Sequence

The traffic signal is operating in a pretimed mode with timing set for maximum recall on both the Lakeview Avenue and the Mammoth Road approaches. The intersection is equipped with emergency pre-emption in only the eastbound and westbound directions (Lakeview Avenue). The signal generally operates under a 3-phase operation plus an exclusive pedestrian phase when activated as shown in **Figure 3**.

The intersection operates with a cycle length of 101 seconds during all time periods with all phases ( $\emptyset 1$ ,  $\emptyset 2$  and  $\emptyset 3$ ) operating under max recall and the pedestrian phase ( $\emptyset 6$ ) as actuated by push button. The Mammoth Road southbound approach first operates with a brief left turn protected advance phase with a 3 second yellow and 2 second all red clearance times then, along with the northbound approach, operates with permitted left turns with a 4 second yellow and 2 second all red clearance times. The Lakeview Avenue phase ( $\emptyset 3$ ) provide permitted left turns and operates with 3 second yellow and 2 second all red clearance times. The traffic signal controller is located in the northeast corner of the intersection within the Costello Square grassed island.

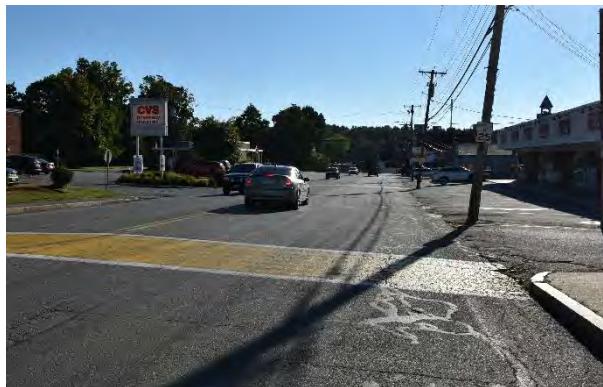
The RSA team also noted that the widths of travel lanes differ within the intersection, and that the approach lanes and departure lanes do not align. Drivers maneuvering through this intersection without knowledge of the misalignment in the travel lanes may result in sideswipe type collisions. The alignment of the lanes for vehicles travelling straight through eastbound or westbound on Lakeview Avenue partially line up with the opposing dedicated left-turn lanes. During the RSA field walk vehicles were observed to travel straight from a dedicated turn lane due to the poor alignment of the approach and departure lanes.

**Figure 4.** Lakeview Avenue looking east towards Mammoth Road. Wide turn lanes and nearby commercial curb cuts.

- Consider a mill and overlay for the intersection to improve the current surface condition.
- Consider full depth reconstruction on the southbound approach and other approaches to the intersection to enhance the subsurface roadway structure.

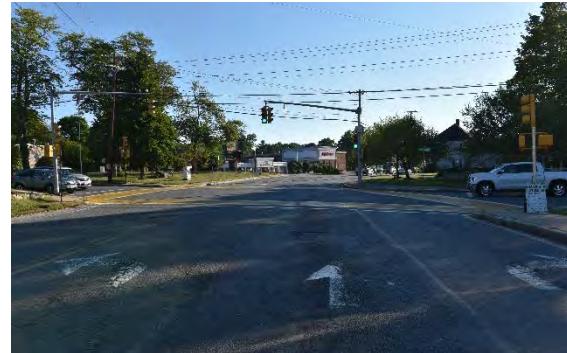
**Figure 5.** Lakeview Avenue eastbound approach. Significant difference in width between approach and departure lane. Worn pavement markings.

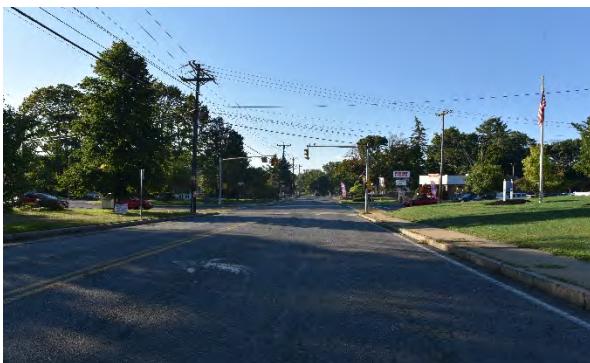
Field observations indicate that the pavement markings on the approaches to the intersection are fairly worn down, especially the turn lane lines and arrows, as well as the crosswalk paint on the four approaches. Worn wheel tracks in the lanes also make visibility of these pavement markings more difficult where markings are provided.

**Figure 6.** Worn pavement markings on Mammoth Road southbound approach to Lakeview Avenue. Including pavement rutting in southbound lanes.

- Consider refreshing worn pavement markings on the Mammoth Road and Lakeview Avenue approaches.
- Consider replacing older style mast arms with current mast arms to hold additional signal heads and hold the current ones higher over the road to increase visibility.
- Provide updated pedestrian signals with countdown style pedestrian heads, ADA compliant push buttons, and audible warning to improve pedestrian safety.
- Conduct a formal sign and signal reflectivity/visibility assessment and replace non-compliant or faded signs to improve visibility and reduce confusion.
- Consider adding dotted white lane extension lines as a temporary enhancement to alleviate driver confusion.
- Provide/repost missing 25 mph speed limit (R2-1 [25]) signs along Lakeview Avenue and Mammoth Road.

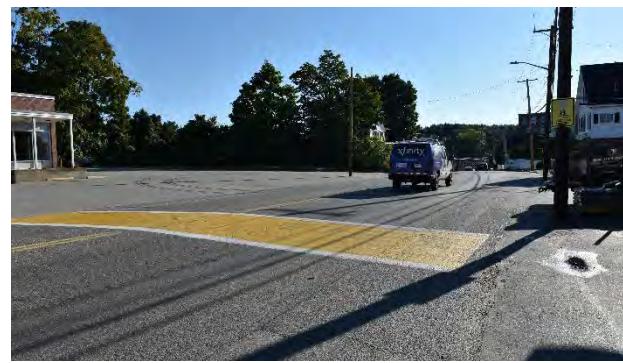
**Figure 7.** Midblock crosswalk not connected to sidewalks on either side of Lakeview Avenue. A non-MUTCD compliant crosswalk warning sign.

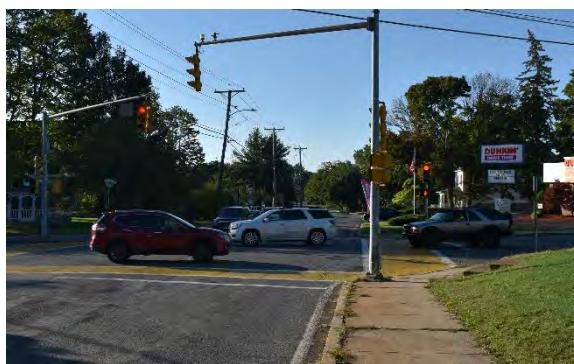
Field observations indicated that southbound left turn lane gets a short, advanced phase ( $5\pm$  second green plus 5 second clearance). There is no signage or arrow signal indications designating the lead phase on the Mammoth Road southbound protected approach for the protected left turn lane. This lack of information can often lead to southbound vehicles making left turns in front of northbound through traffic advancing into the intersection. The short lead time can also encourage vehicle operators to speed in the southbound approach in order to make the light before northbound cars can begin to enter the intersection. This issue can be seen in the number of angle-type collisions between southbound and northbound travelling vehicles.

**Figure 8. Mammoth Road southbound approach signal heads do not have arrow indications for protected phase. Pedestrian push button in northeast corner of intersection needs updating to be accessible.**

- Consider updating the traffic signal controller, traffic signal controller cabinet and foundation to current standards.
- Consider installing yellow reflective back plates on all signal heads to improve visibility.

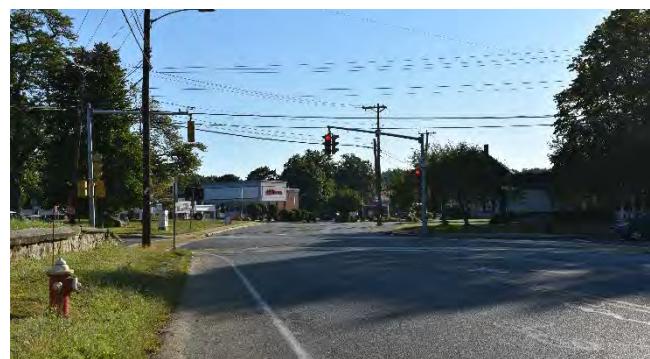
**Observations:** Field observations indicated that the traffic signals at the intersection are primarily hung from two mast arm poles located on the southeast corner and northwest corner of the intersection. Based on the traffic signal layout plan for the intersection and field review, the two eastbound signal heads do not provide enough information for the three eastbound approach lanes. Additionally, it was noted that it is difficult to see the traffic signal heads for the southbound through/right turn lane due to the skewed location and position of the pole.

**Figure 9. Lakeview Avenue eastbound approach provides only two signal heads for three travel lanes.**

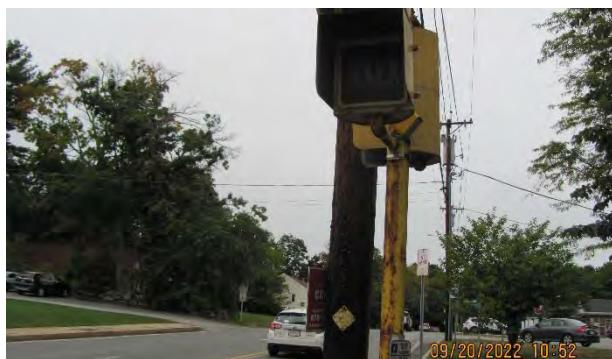
**Observations:** Field observations indicated that there are crosswalks across each approach at the study intersection, but the sidewalks along the approaches do not provide enough coverage to the potential destinations nearby. There is a small section of sidewalk provided along the northwest corner of the intersection that provides access to the Dracut School administration building at the corner of the study intersection, however any destination further to the north along Mammoth Road or west along Lakeview Avenue does not have access via sidewalk. Similarly, the sidewalk in the northeast corner of the intersection provides access to the green space within Costello Square (i.e., the channelized island between Lakeview Avenue and Brown's Lane), but further destinations, including crossing Brown's Lane, are not connected to this sidewalk. There are handicapped ramps provided at the four corners of the intersection and audible warnings are provided for pedestrians utilizing the crosswalk push button, but no tactile warning panels are included on the ramps. The RSA team also noted the push buttons on a few of the corners of the intersection need to be updated to be more accessible. Further to the east along Lakeview Avenue, multiple other crosswalks are provided in proximity to one another.

**Figure 10.** Older pedestrian signal heads do not provide a countdown timer on some corners of the intersection. Some push buttons need updating too.

- Consider providing curb ramps and crosswalks within the intersection and along Lakeview Avenue and Mammoth Road to improve pedestrian safety.
- Consider providing ADA compliant sidewalk sections for missing segments.

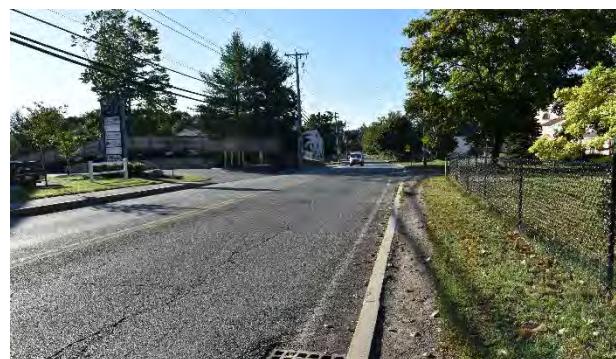
Additionally, there are currently no bicycle accommodations at the intersection or roadways (Lakeview Avenue and Mammoth Road). Given the lack of accommodations, the pedestrian and bicycle activity are relatively low; however, pedestrians and bicycles do navigate the intersection on a daily basis between the residential uses in the area and the local shops, parks, and the Dracut Schools located to the east along Lakeview Avenue. The RSA team noted an increase in pedestrian and bicycle activity corresponding with the local schools' release time in the 2:00 PM and 4:00 PM window. A review of the crash records indicates that one crash involving a pedestrian and one involving a bicyclist were reported within the RSA study area, but outside of the signalized intersection over the five-year study period. It was noted that pedestrians also walk along the west side of Mammoth Road to the south of the intersection on the grass shoulder, as evidenced by worn grass between the Dunkin' and the church to the south.

**Figure 11.** Sidewalk on west side of Mammoth Road ends abruptly in both the north and south directions. Worn down grass shows high volume of pedestrian activity.

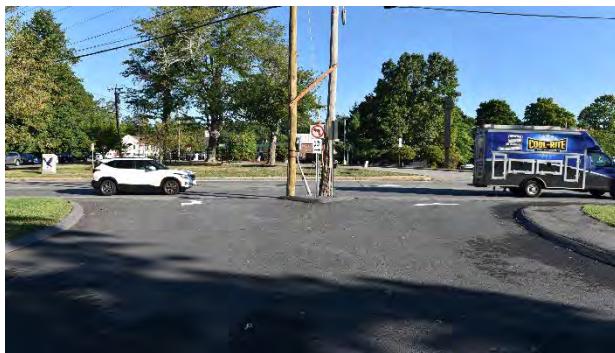
**Observations:** The RSA team noted that approximately 40% of the crashes at the intersection occurred outside of daylight hour under dusk or dark roadway conditions. Field observations indicated that lighting of the intersection is limited to two streetlights, one on the northwest corner of the intersection and one in the southeast corner. The adjacent land uses have parking lot/driveway lighting nearby, but the intersection may not have adequate lighting on its own. The RSA team noted a recent crash had broken a streetlight near the southeast corner of the intersection at the right-in/right-out office driveway on Lakeview Avenue.

**Figure 12. Streetlight on Lakeview Avenue just east of intersection not repaired after recent crash took it down.**

- Evaluate lighting within the intersection and fix broken lighting fixtures.
- Provide additional lighting if required to improve nighttime visibility.
- Evaluate pavement condition within the intersection and potential solutions to pavement rutting issues, especially along Mammoth Road.
- Provide catch basin maintenance to remove debris.
- Evaluate and include a full drainage design with any future changes to the intersection.
- Work with the utility companies to relocate or secure underground utilities. Issues with the underground equipment results in utility vehicles parking in the intersection, causing potential conflicts with other vehicles.

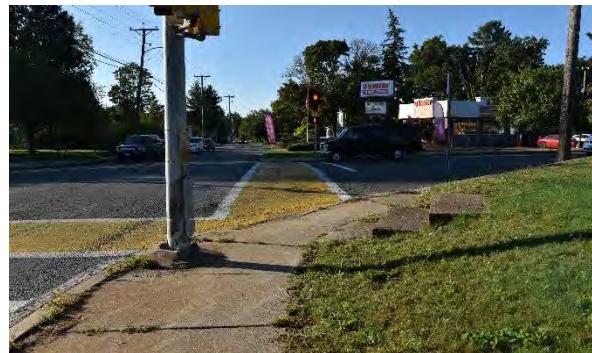
Drainage at the intersection was noted to be an issue in wet/snow weather conditions. Notably in the northwest corner of the intersection there are no catch basins, oftentimes forcing water in that corner to pool up or even drain into the existing utility manhole. Issues with the underground equipment beneath the manholes results in utility vehicles parking in the intersection to manage this equipment, causing potential conflicts with other vehicles.

**Figure 13. Lack of drainage options at a low point in the northwest corner of the intersection.**

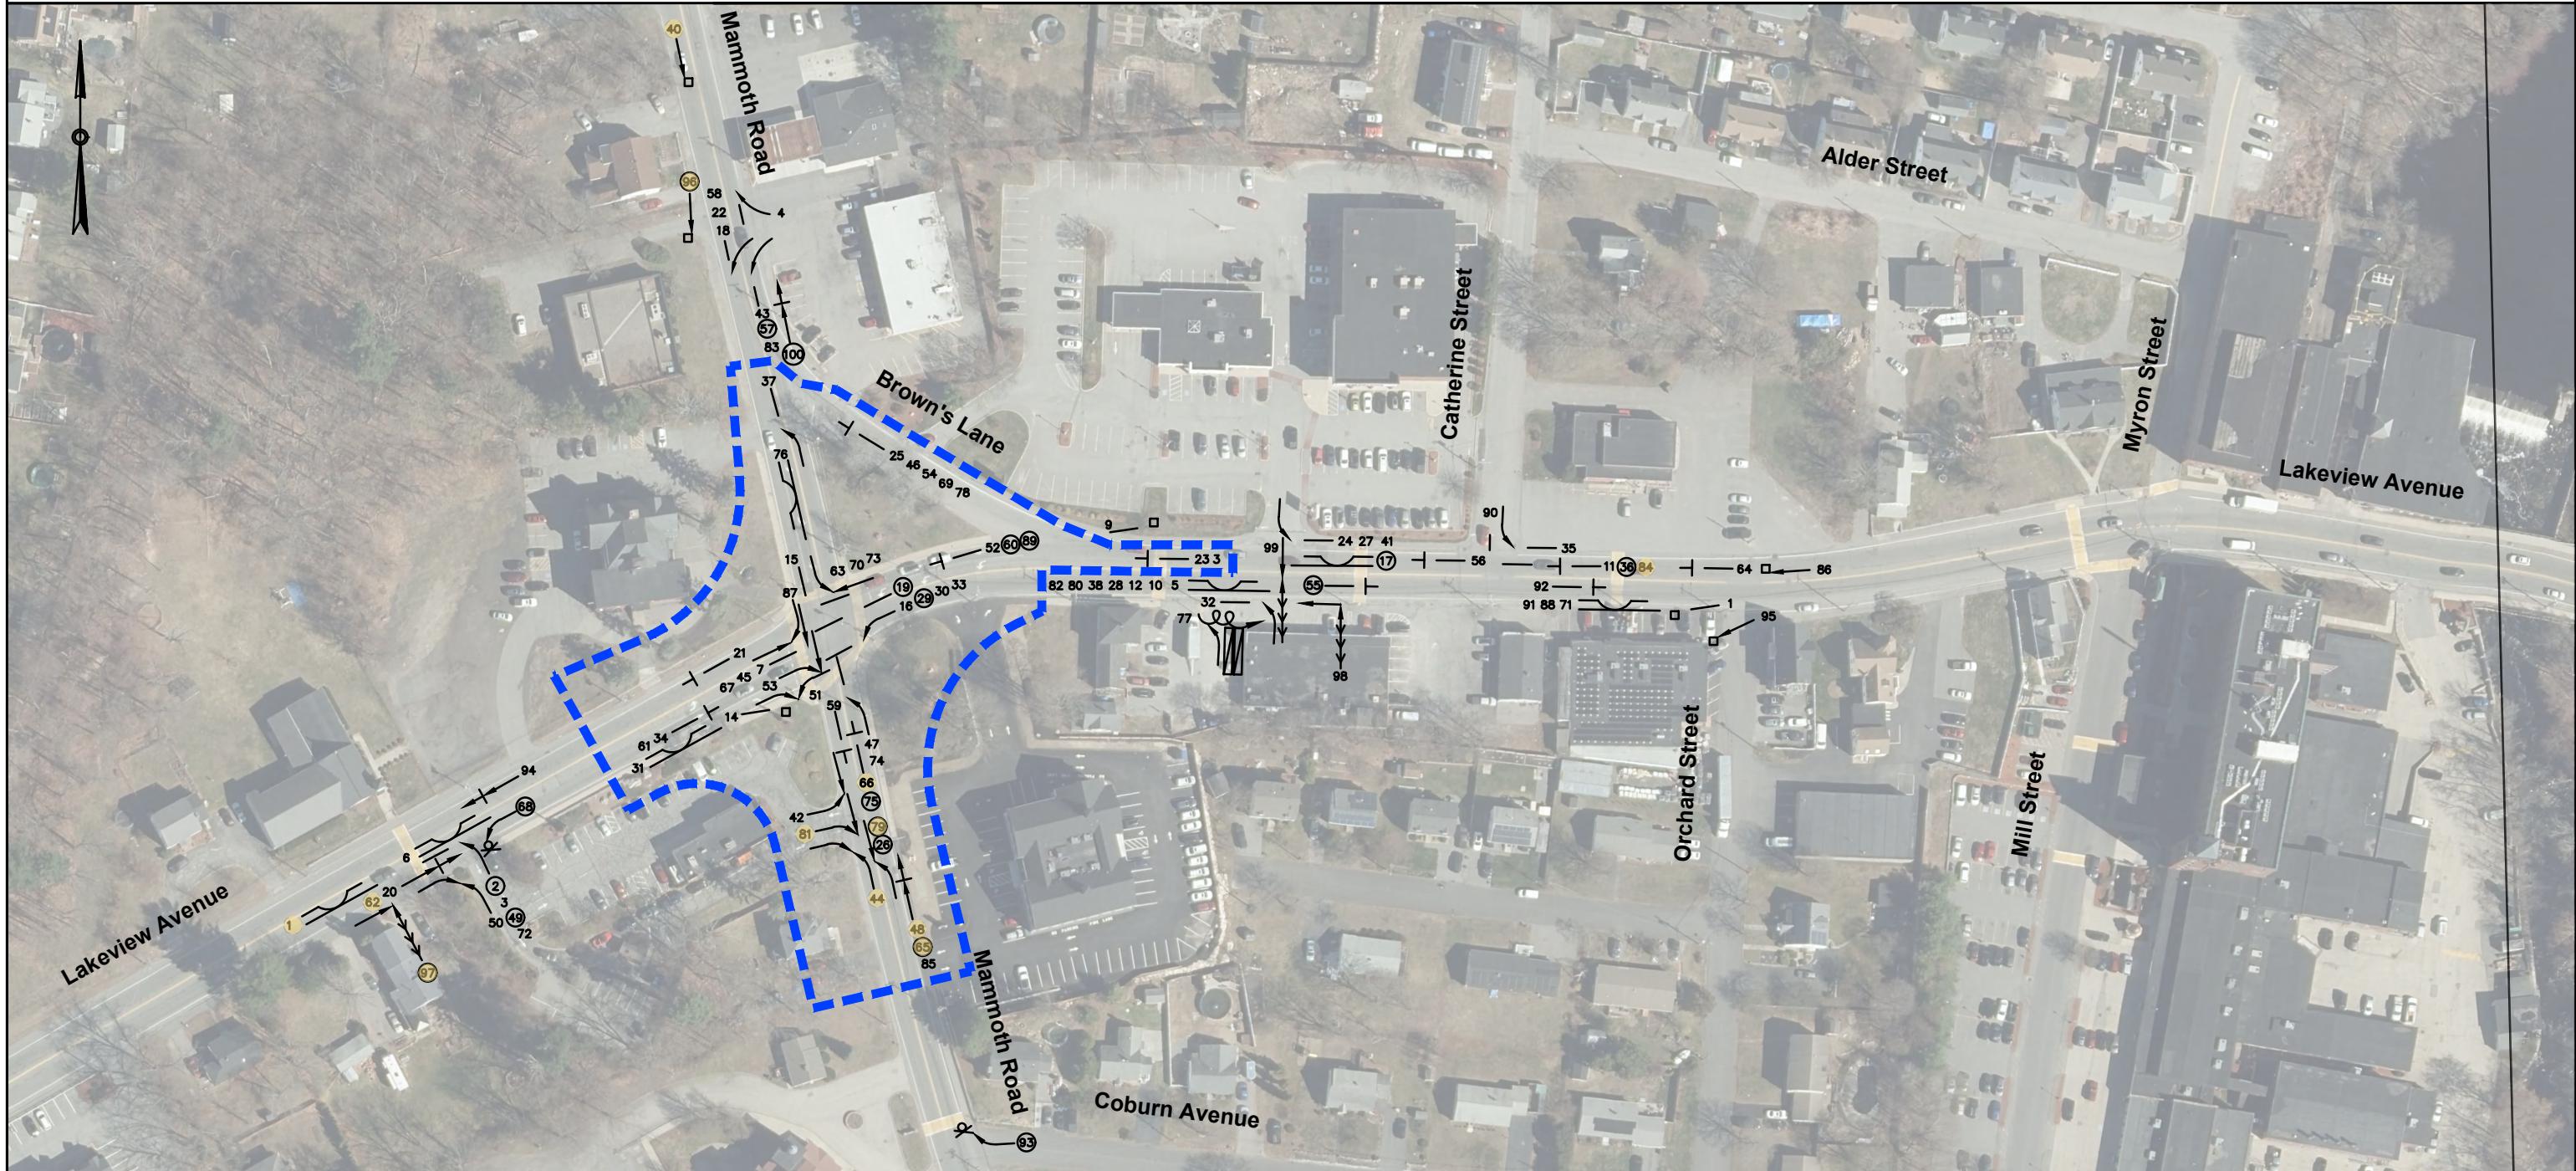
# COLLISION DIAGRAM

The collision diagram provides a graphical representation of the crash data showing both the crash type and approximate crash location within a study area. The collision diagram also shows the severity of the crash and the daytime versus nighttime conditions. The audit members were asked to review the packet and visit the RSA study area prior to the meeting.

STUDY AREA Mammoth Road and Lakeview Street  
 PERIOD 2017-2021 FROM January 2017 TO December 2021  
 CITY Dracut PREPARED BY GRD
