# DRACUT SENIOR HOUSING FEASIBILITY STUDY

# EXECUTIVE SUMMARY

4  
GEOTECHNICAL REPORT

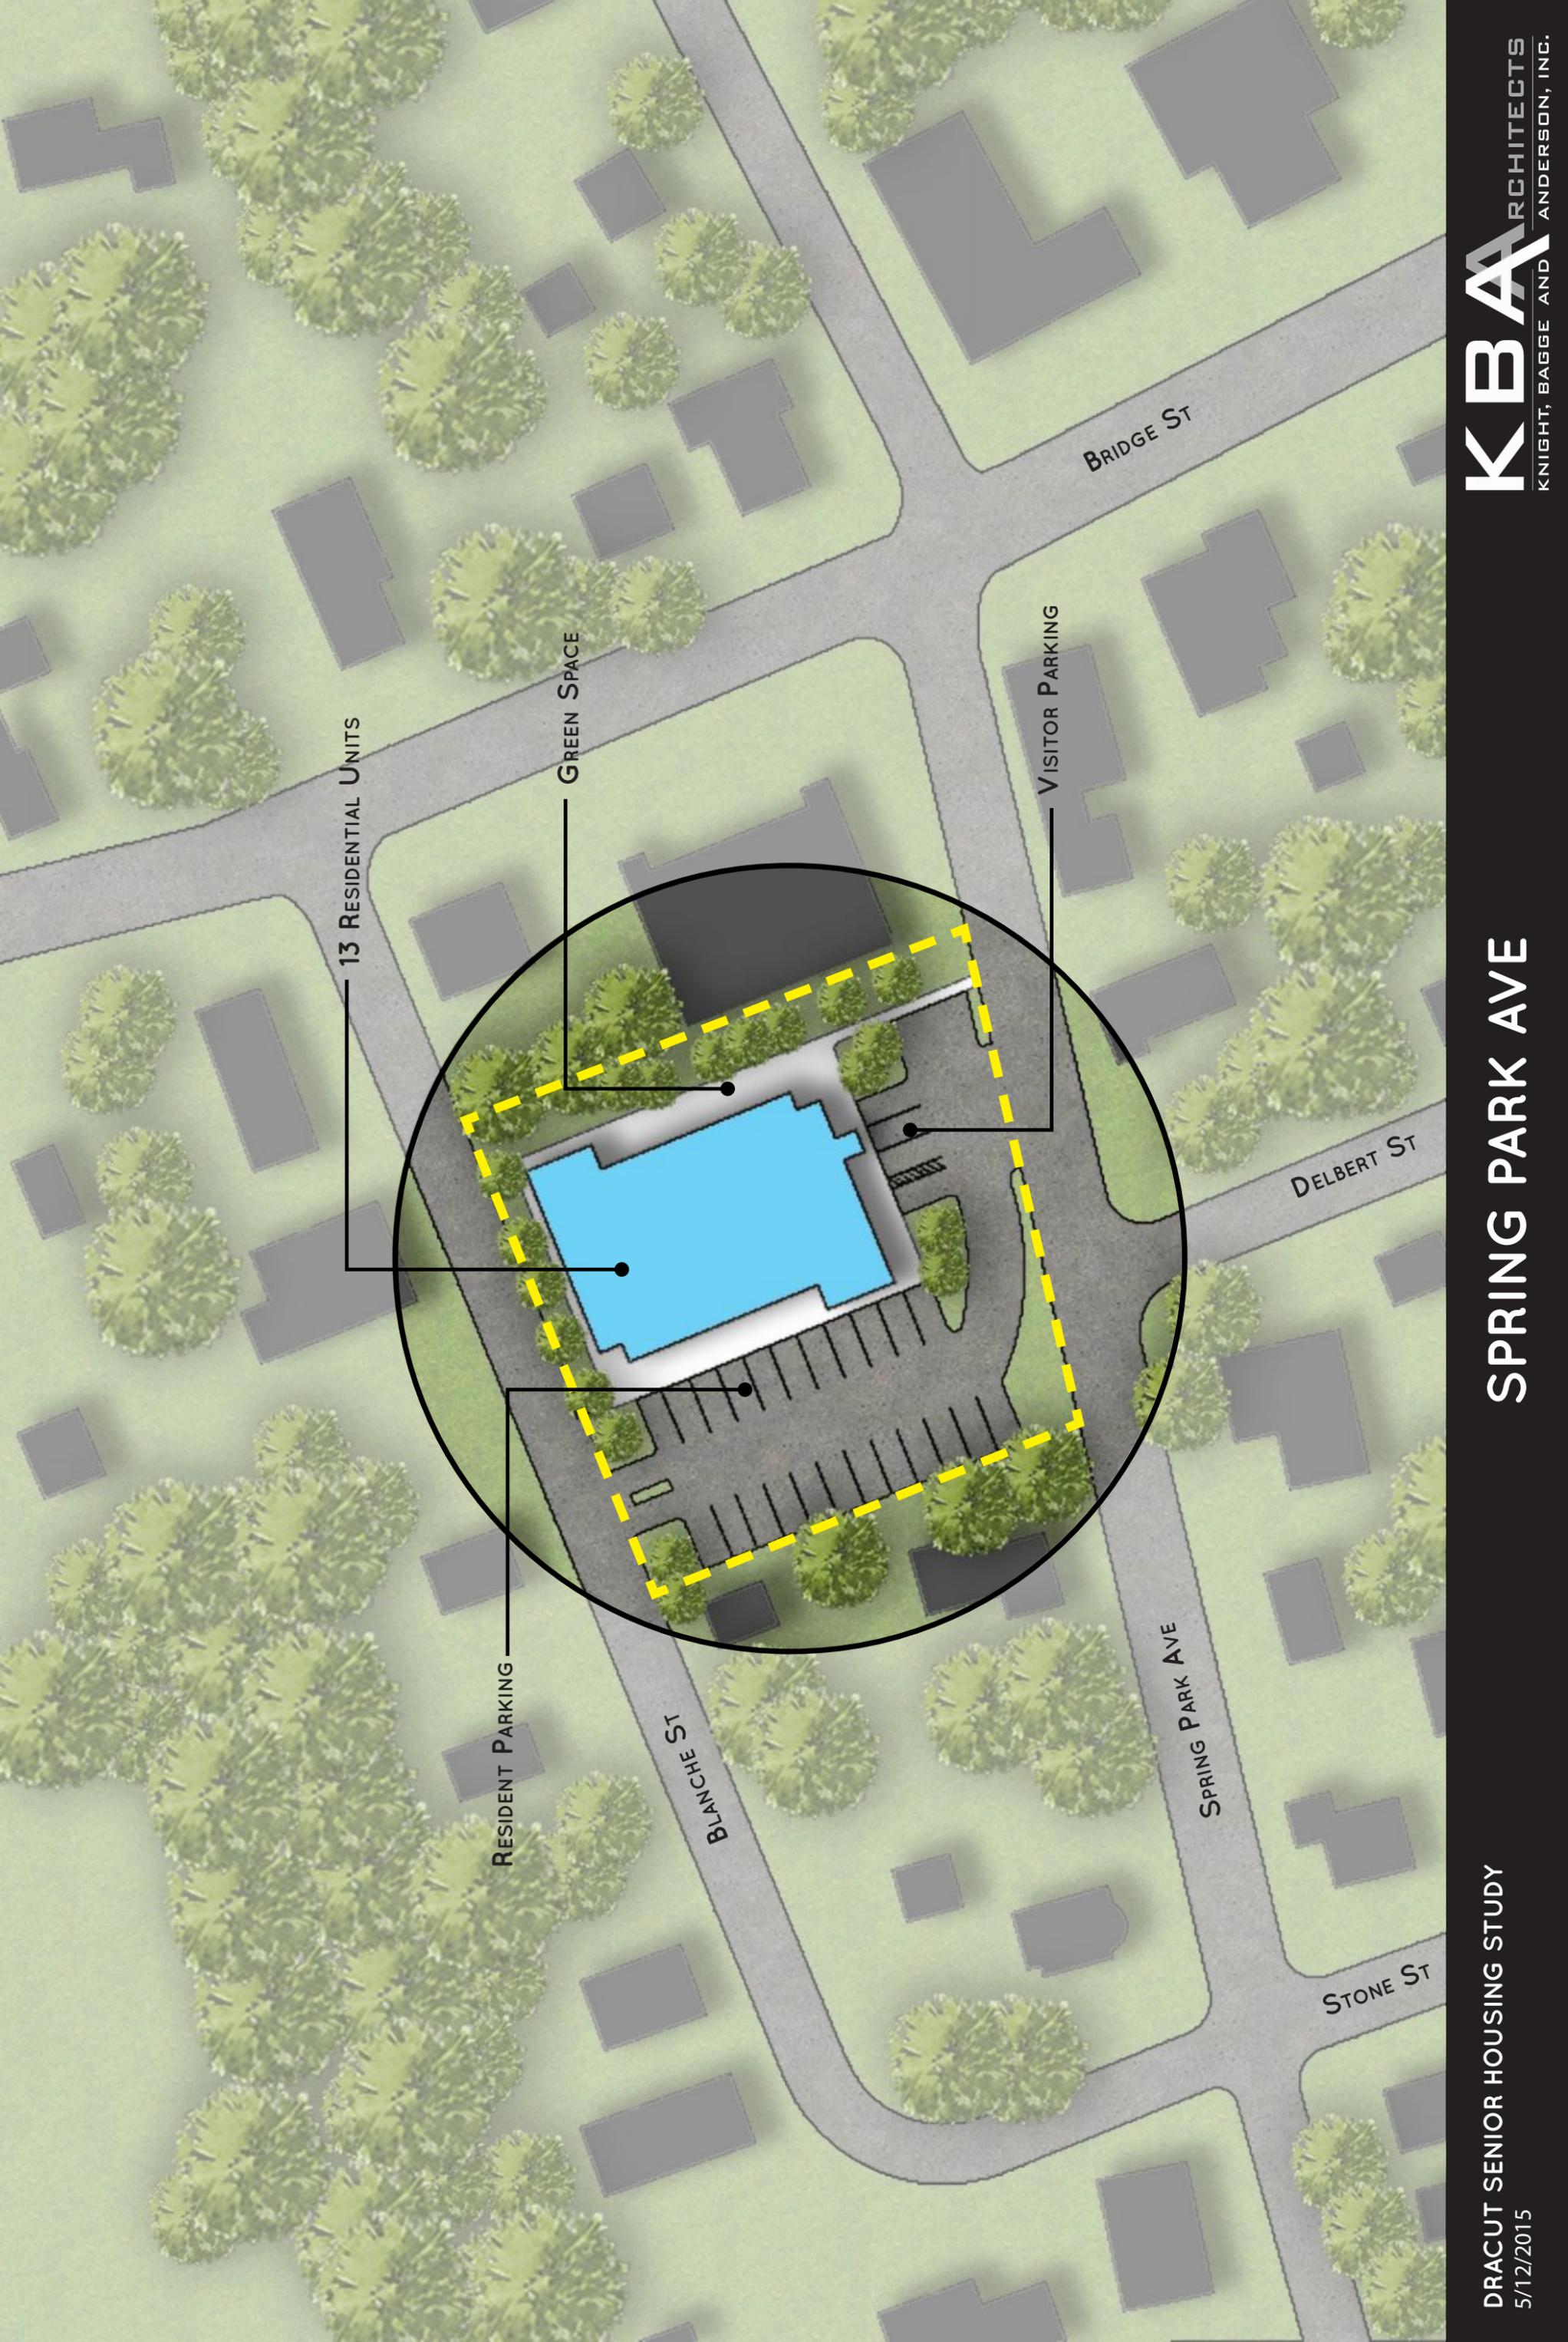
13 RESIDENTIAL UNITS

GREEN SPACE

The Spring Park parcel will require the razing of the existing structure, which can be seen on the “Spring Park Avenue Existing Site” plan. The proposed building is 7,280 square feet per level for a total square footage of 14,600, and has been designed to be a two story structure meeting the unit count requested and additional spaces for office, custodial, and multi-function room for gatherings. Toilet facilities for men and women are also accommodated adjacent to the function space for use by the occupants and guests utilizing the facility. The floor plans, all single level with first floor interiors meeting accessible criteria and proposed elevations for Spring Park, can be seen on the following pages. The site can also accommodate 27 parking stalls, with access from Spring Park on the south and Blanche Street on the north side.

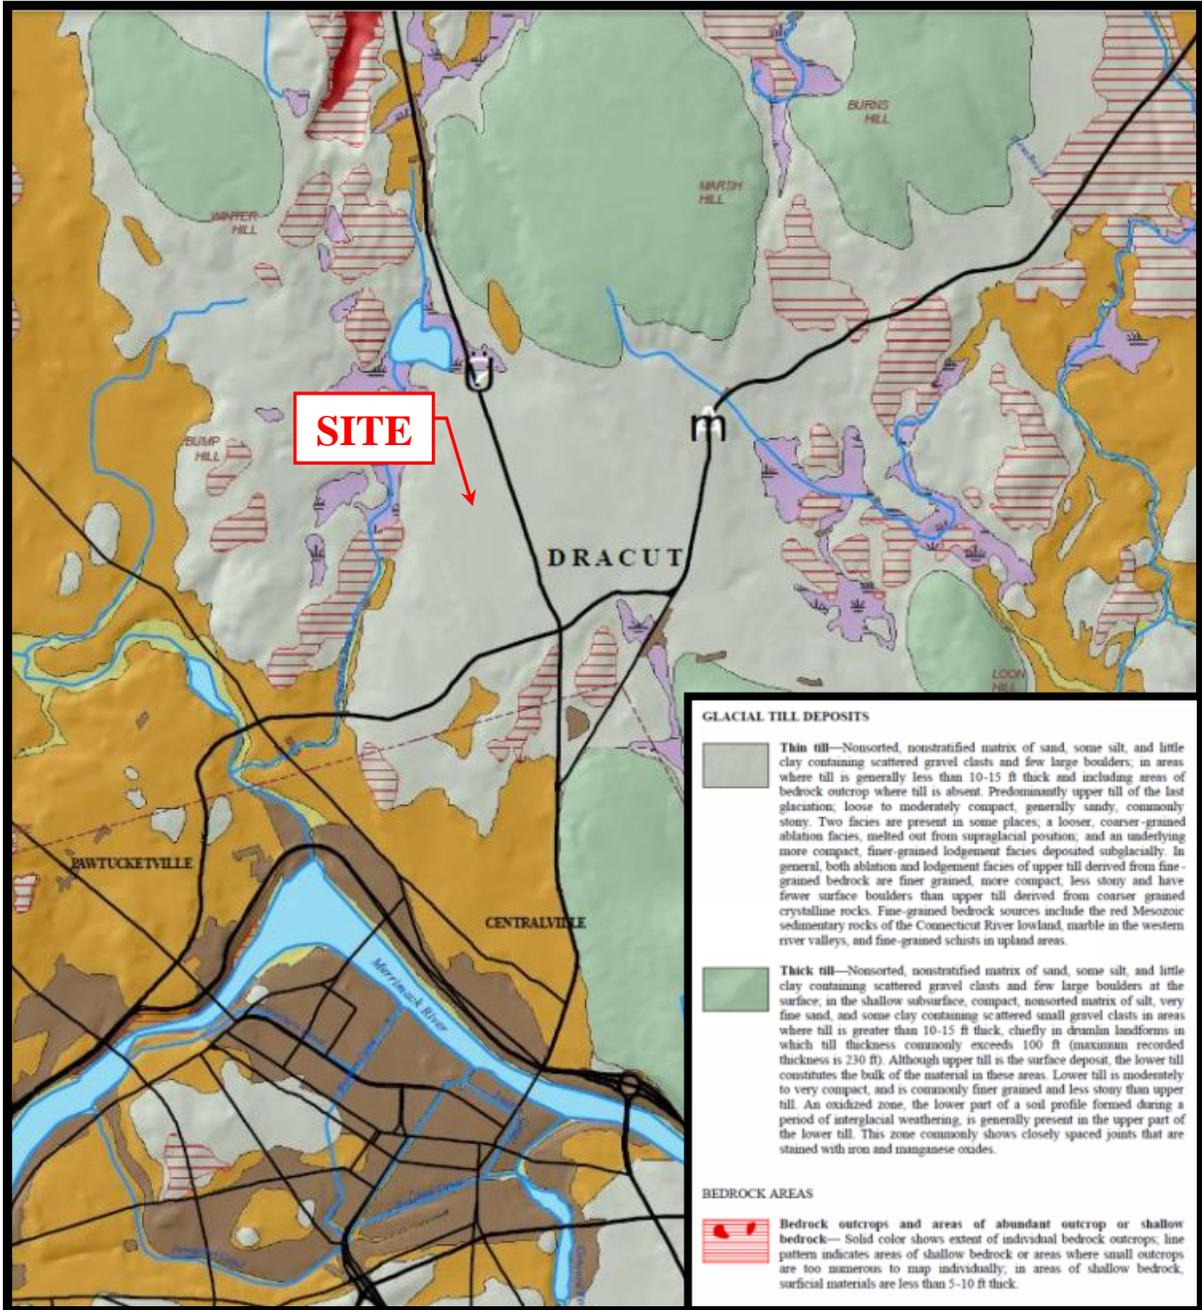
FIGURE 3: SURFICIAL GEOLOGY

**REFERENCE:** "SURFICIAL GEOLOGIC MAP OF THE ASHBY-LOWELL-STERLING-BILLERICA 11-QUADRANGLE AREA IN NORTHEAST-CENTRAL MASSACHUSETTS"  
Byron D. Stone and Janet R. Stone - 2007

Based on the “Surficial Geologic Map of the Ashby-Lowell-Sterling-Billerica 11-Quadrangle Area in Northeast-Central Massachusetts” compiled by Byron D. Stone and Janet R. Stone in 2007, the surficial geology of the project site is thin glacial till deposits, which consists of nonsorted, nonstratified matrix of sand, some silt, and little clay containing scattered gravel clasts and few large boulders. This is shown in *Figure 3, Surficial Geology*. The explorations undertaken at the site generally conform to this description.

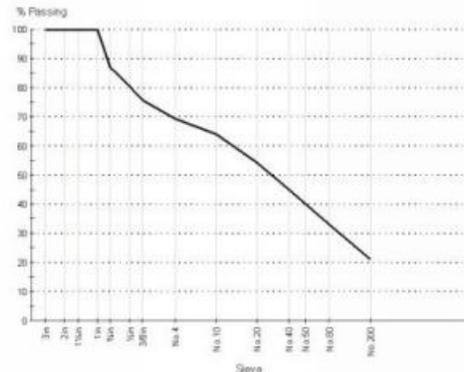
Sieve Size	% Passing	Limits
3in (75.0mm)	100	
2in (50.0mm)	100	
1½in (37.5mm)	100	
1in (25.0mm)	100	
¾in (19.0mm)	87	
½in (12.5mm)	80	
3/8in (9.5mm)	76	
No.4 (4.75mm)	69	
No.10 (2.0mm)	64	
No.20 (850µm)	54	
No.40 (425µm)	45	
No.50 (300µm)	40	
No.80 (180µm)	33	
No.200 (75µm)	21

<b>Gradation Test Results – B-2 (2 to 4 feet)</b>	
Moisture Content (%)	10.1
USCS Classification	Silty Sand with Gravel (SM)

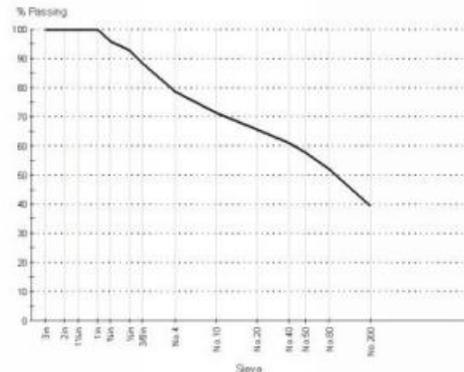
Description	Method	Result	Limits
Moisture content (%)	ASTM D 2216	10.3	
Method		B	
Date Tested		5/12/2015

<b>Gradation Test Results – B-2 (5 to 7 feet)</b>	
Moisture Content (%)	10.3
USCS Classification	Silty Sand with Gravel (SM)

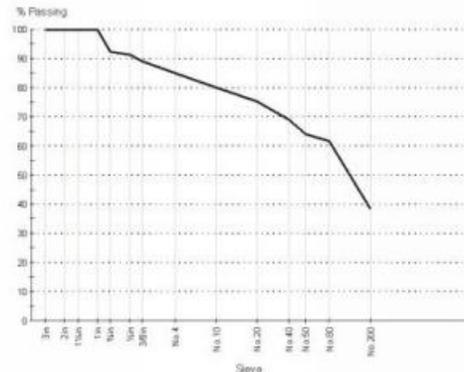
Sieve Size	% Passing	Limits
3in (75.0mm)	100	
2in (50.0mm)	100	
1½in (37.5mm)	100	
1in (25.0mm)	100	
¾in (19.0mm)	92	
½in (12.5mm)	91	
3/8in (9.5mm)	89	
No.4 (4.75mm)	85	
No.10 (2.0mm)	80	
No.20 (850µm)	75	
No.40 (425µm)	69	
No.50 (300µm)	64	
No.80 (180µm)	62	
No.200 (75µm)	38

<b>Gradation Test Results – B-4 (5 to 7 feet)</b>	
Moisture Content (%)	11.3
USCS Classification	Silty Sand with Gravel (SM)
